**PROBLEM SITUATION**

4819 – Mustang hood line aerial cam flange die

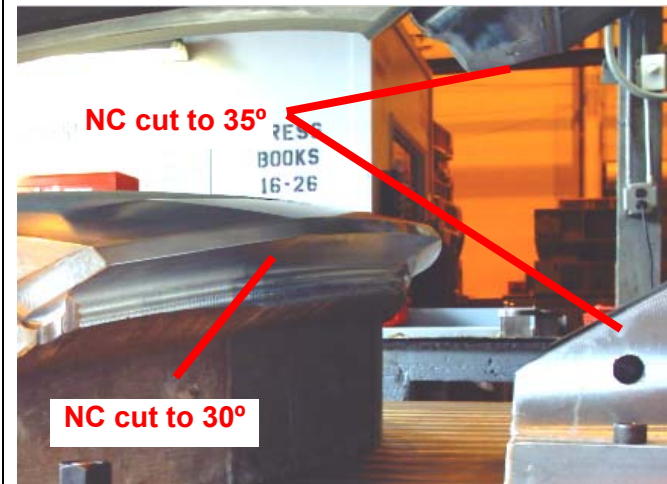
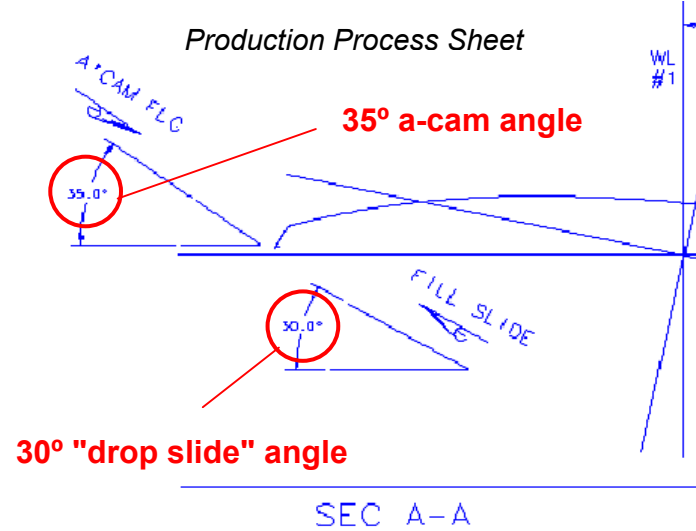
- Tools correctly programmed and cut to supplied surfaces from Surfacing group
- Die designs supplied to NC surface had 35° on all cam surfaces
- Surfacing group consulted with Program Manager to modify post angle to match production die process angle (for drop slide)
- Drop slide mechanism shown in production die process is not part of prototype die design
- WDX standard requires production drop slides to be 5° less than the aerial cam angle to enable automated panel removal

Resultant rework to correct problem totaled 56 man and equipment hours. Scheduled load date was missed resulting in additional errors and rework totaling 220 hours.

**PROBLEM:** Cam flange driver and slide angles do not match cam flange post angle.  
**MOST LIKELY CAUSE:** Cam flange post incorrectly machined to 30° angle versus machining of cam drivers and slides to 35°.

**WHY?** NC cutter path supplied to the mills reflected 30° for cam flange post and 35° for cam flange drivers and slides.  
**WHY?** Die surfaces supplied to NC programming reflected 30° for post and 35° for drivers and slides

**WHY?** Surfacing group modified die design for post to use 30° cam angle instead of 35°  
**WHY?** Surfacing group reviewed the production die process sheet and incorporated the 30° angle of the production drop slide believing that there was an error in the die design.

**WHY?** Surfacing group was not aware of the 5° undersize WDX standard for production drop slides  
**ROOT CAUSE:** Surfacing group did not consult with die design team (design owner) before incorporating change to prototype die design

1. Incorporate sketch (shown above) describing required cam angle condition into NC programming check sheet for all future cam flange dies.
2. Review A3 and design change approval process with NC surfacing group → Requirement to consult with die design group prior to incorporating design changes
3. Investigate incorporating appropriate operating standards into TDM Lean Enterprise Strategy.
